Thermal imaging cameras from FLIR help optimize low-cost housing solution

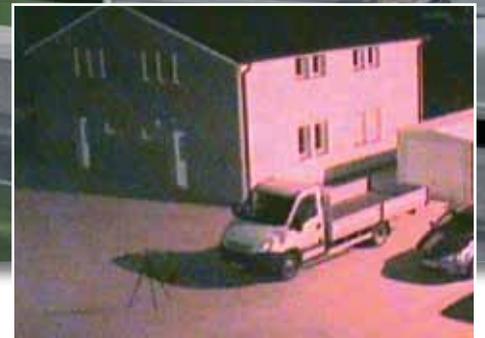
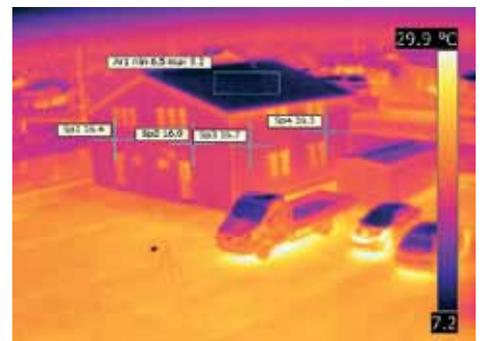
The roof remains cold, even though one of the apartments is heated ($\Delta T = 13^{\circ}\text{C}$). The ridge-tile appears at the same temperature than the roof, which is a sign of well insulated roof.

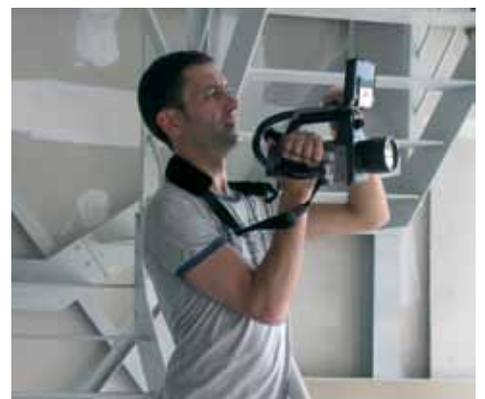
Francis Lamberg inspects the Casa Buna prototype using his FLIR thermal imaging camera.

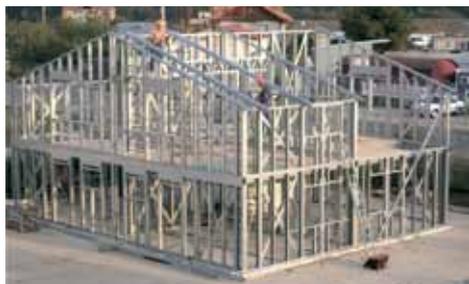
The Casa Buna housing solution is a two-floor house for four families that can be easily constructed by unskilled or semi-skilled volunteers.

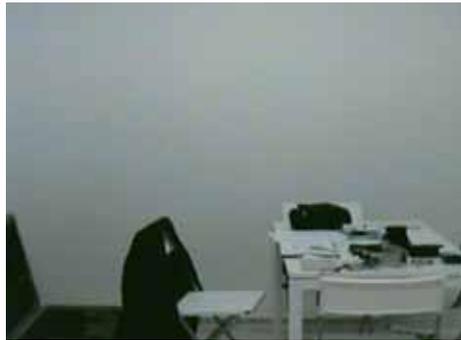
This thermal image shows that the bearing profiles in the indoor partition wall contribute to thermal bridges between the apartments. The new prototype therefore had improved indoor partition wall insulation.

The thermal data Lamberg collected proved that the prototype had some initial insulation design flaws. Lamberg proved that both in the window frames and in the indoor partition walls progress the insulation was imperfect. "We found

several thermal bridges during the inspection. A thermal bridge is an area with less insulation. Heat follows the path of the least resistance. Often heat will 'short circuit' through an element that has much higher conductivity than the surrounding material. This is called a thermal bridge." Luckily both of the insulation problems were easily solved. "A new version was made with these changes implemented, and repeated thermal imaging inspections proved that the new prototype showed no thermal bridges."

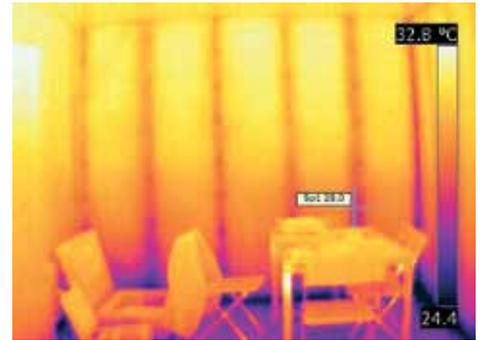
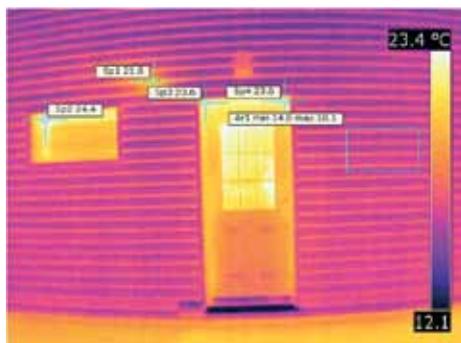
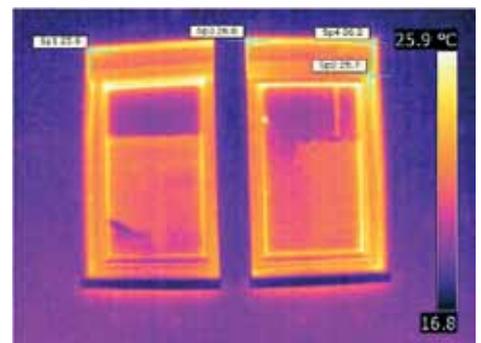
These thermal images show heat leakages from the vented hood and from the lintels of the windows and doors in both the heated and in the non-heated apartments. Room and door insulation was consequently improved.
